AGENDA

Board of Public Works Meeting
Tuesday, January 27, 2015 – 7:00 P.M.
Jackson Village Hall
N168W20733 Main Street

Public Works Report

Definitions of Conditions Found on Your Roof

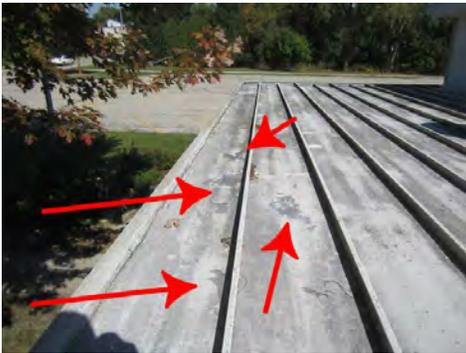
Photo 7

West perimeter. Arrows point to areas where coating is failing.

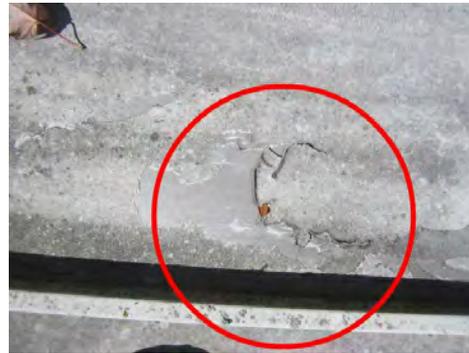
Photo 8

Close up of an area of coating failure.

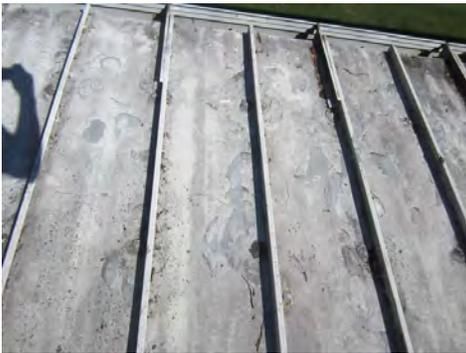
Photo 9

The majority of this roof section's coating has failed or is failing.

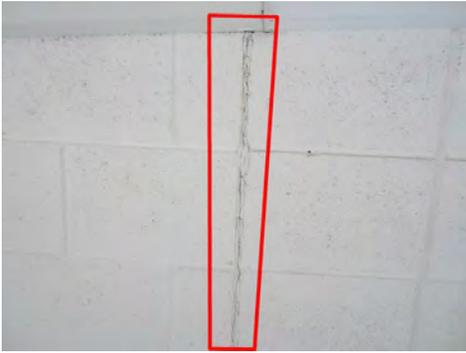
Photo 11

Caulking Deterioration: As caulking is exposed to UV rays and temperature fluctuations it loses its flexibility and develops cracks. Once this occurs splits develop instantly allowing water to penetrate walls and buildings causing damage as well as leaks.

Caulking Deterioration in control joint

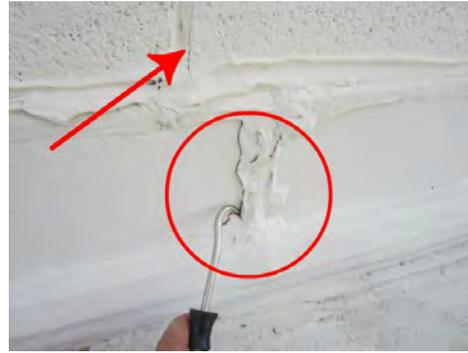
Photo 12

Excessive amounts of caulk applied throughout the years, some of which is no longer watertight.

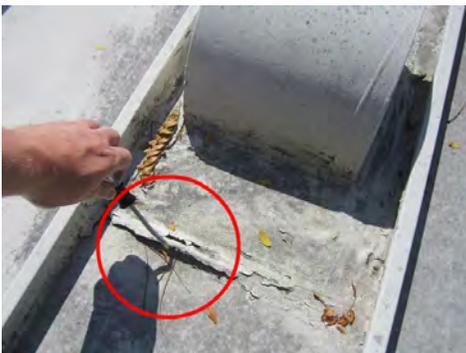
Photo 15

Vent's flashing is no longer watertight and caulk has deteriorated.

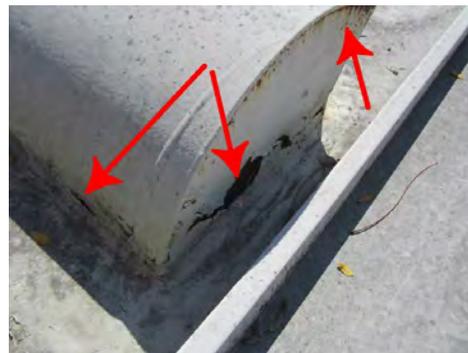
Photo 16

Coating is peeling off the vent and corrosion is occurring.

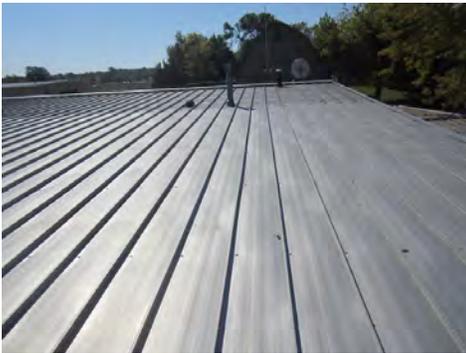
Photo 5

Oil Canning was found on every panel. This condition occurs when the metal panels flex during hot and cold cycles and are not allowed to move due to fasteners holding them in place. Over time this condition will lead to roof failure.

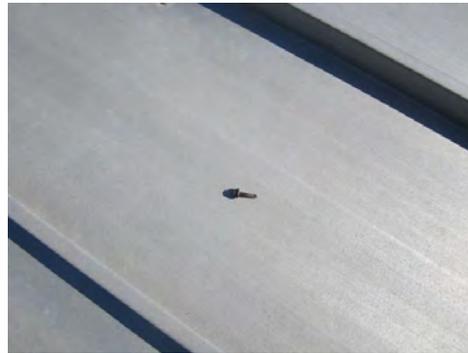
Photo 6

Fastener Back-Out: This is a very common condition on any type of mechanically fastened roof where no recovery board is installed over the fastener, thermal bridging occurs. This causes the fasteners to back out of the deck slowly creating a tent like appearance on the roof and eventually causing punctures. Water can then enter the building and walls causing leaks.

Fastener that backed out

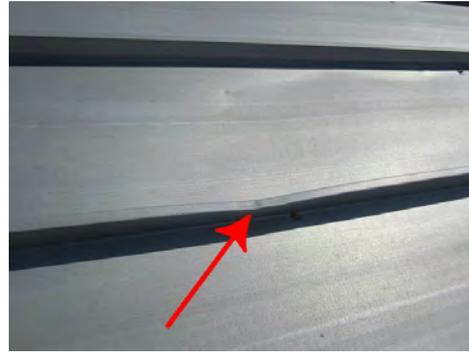
Photo 8

Damaged seam that could rust if untreated.

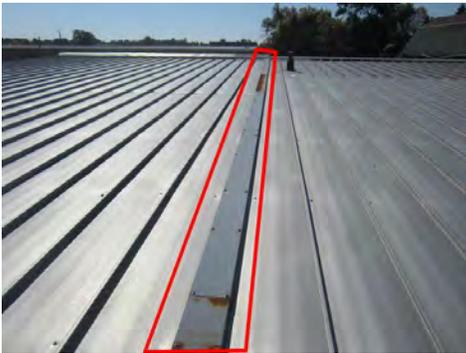
Photo 9

Joint used to connect an addition. Sheet metal is not galvanized and rusting.

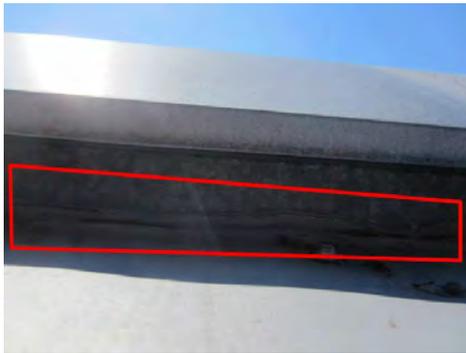
Photo 13

View under ridge cap exposing caulk as the last line of defense against water infiltration.

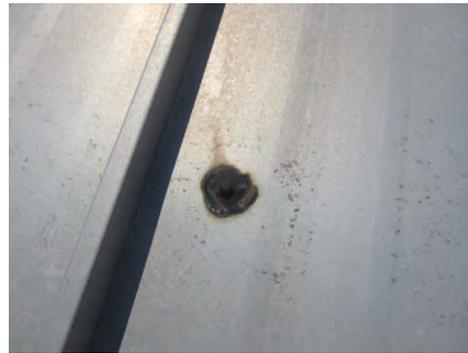
Photo 14

Many fasteners on the roof are rusting like this one.

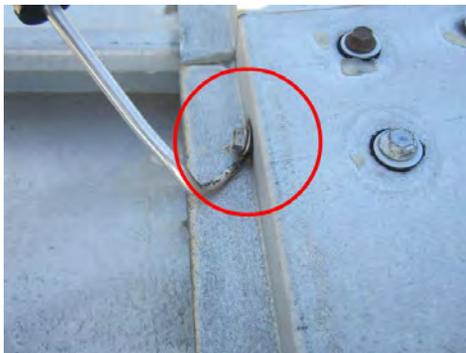
Photo 15

Fastener that is not flush with the metal panel.

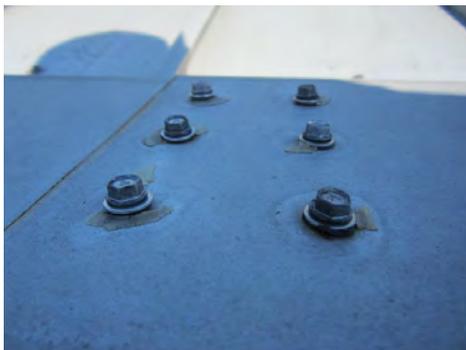
Photo 17

Sealant around the fasteners in this picture has failed.

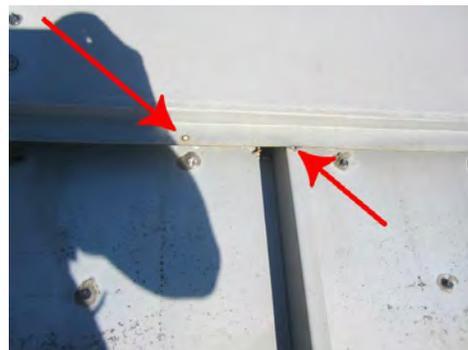
Photo 18

Hole in standing seam doesn't line up with the hole in the ridge cap. Was this by accident or by design?

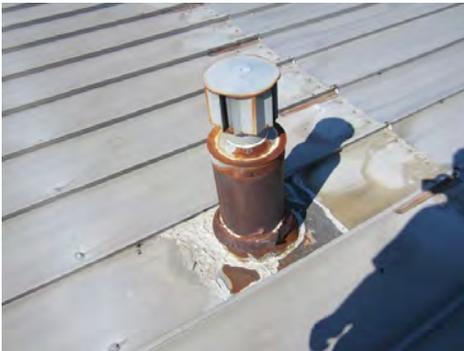
Photo 21

This penetration has been the source of a leak for awhile and has been repaired multiple times without success.

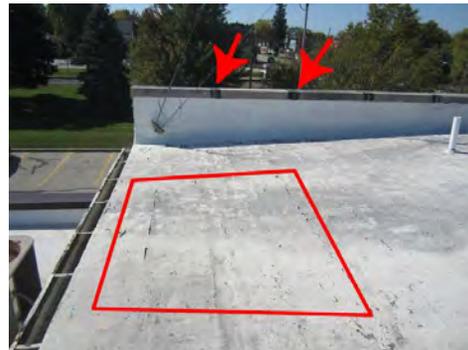
Photo 2

Coping Stone Joint Deterioration: Coping stone joints commonly leak due to the expansion and contraction that takes place between the pieces of stone that make up the caps. In addition, a combination of factors such as poor joint design, poor installation, and incorrect material choice may cause the sealant in the joint to fail. Once the joint leaks, water will infiltrate the roofing system, saturate the insulation at the base of the parapet wall, and leak in to the building.

South perimeter. Large area of failed coating in boxed area. **Coping Stone Joint Deterioration** along the West perimeter.

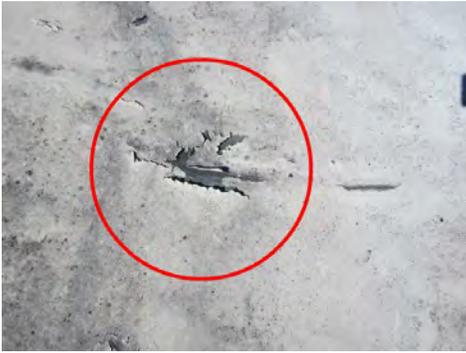
Photo 3

Close up of coating that is failing.

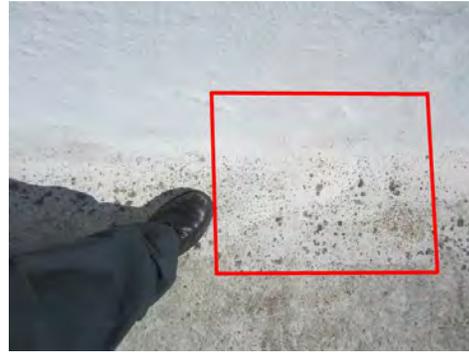
Photo 4

Large **Water Blister** along the East perimeter of the roof section. Water is trapped between the coating and original roof.

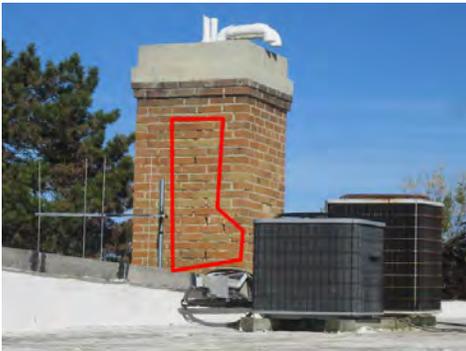
Photo 5

Tuck Point Deterioration around chimney.

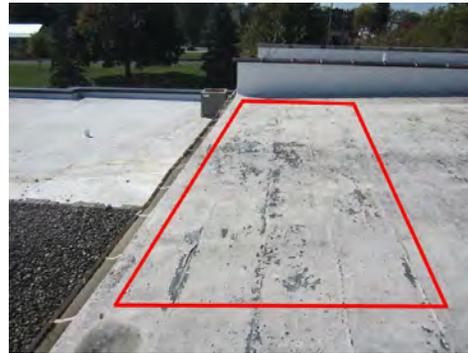
Photo 2

South perimeter and areas of coating failure.

The best long term option is to repair the membrane for active leaks and then replace the system as soon as monies allow.

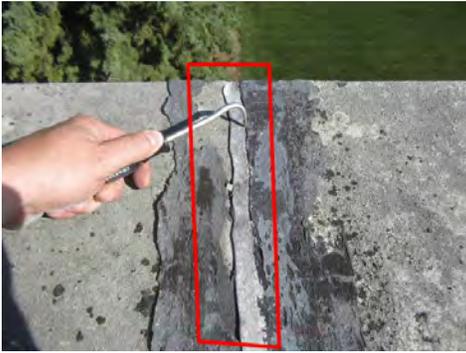
Photo 5

Coping Joint Deterioration along the East perimeter

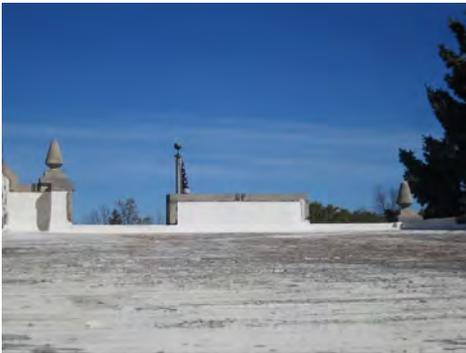
Photo 7

View of the coating failure on this roof

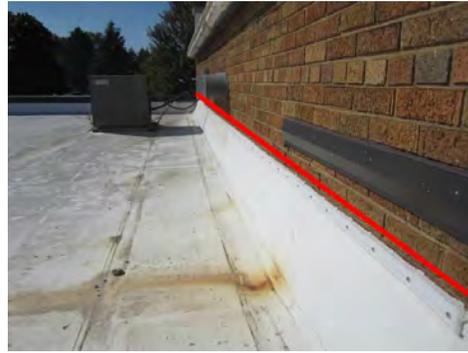
Photo 4

Caulking Deterioration along the termination bar located at the North perimeter.

The best long term option is to repair the membrane for active leaks and then replace the system as soon as monies allow.

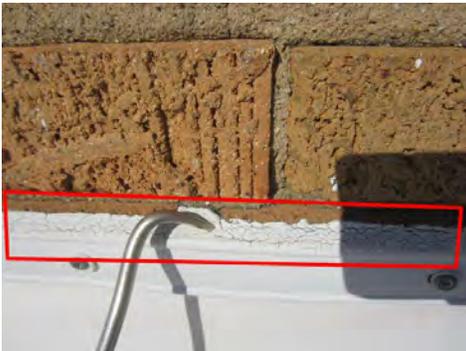
Photo 5

Close up of the **Caulking Deterioration** along the termination bar.

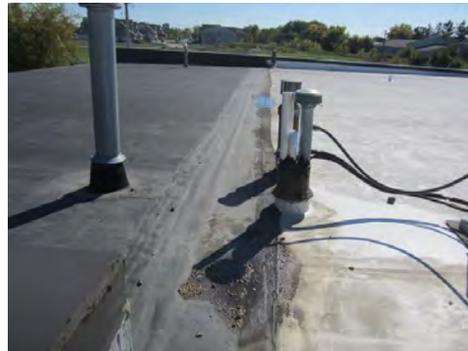
Photo 6

Two different roof sections meet in this photo. The adhesives have failed and water is entering both systems along this detail.

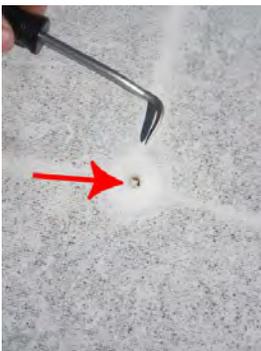
Photo 7

Puncture in the field of the roof.

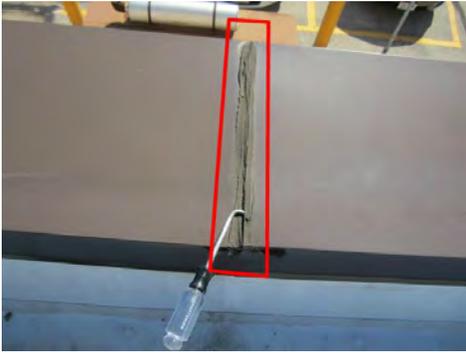
Photo 9

Caulking Deterioration located at coping cap joints along South and West perimeters.

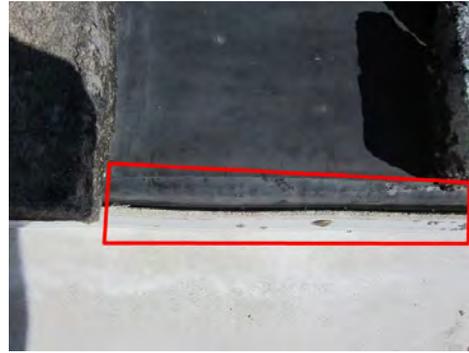
Photo 10

Transition between roof sections. Some of the water flowing from the upper roof to the lower roof is getting under the lower roof's membrane through the detail shown. This termination bar is not watertight and is a poor design.

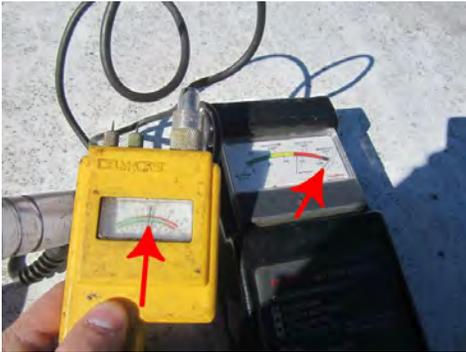
Photo 11

Both moisture meters detected **Wet Insulation**. I cored this area to confirm the meter's findings.

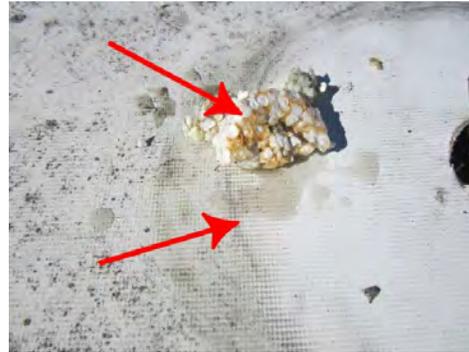
Photo 12

EPS insulation is soaking wet and discolored. Water in photo came from the core sample.

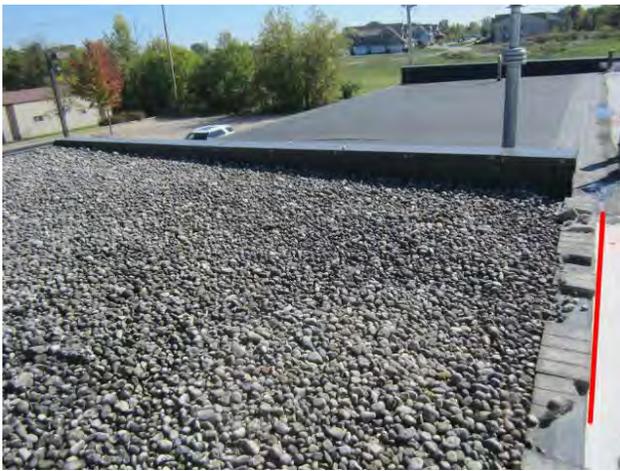
Photo 2

West perimeter where failing termination bar is located.

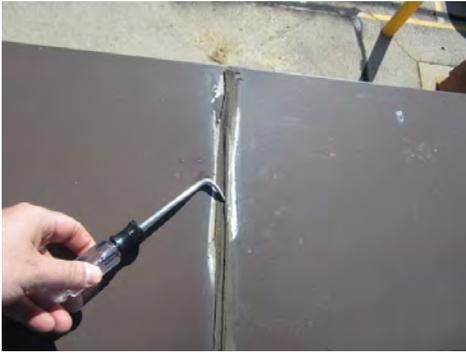
Photo 3

Caulking Deterioration along coping cap joints.

The best long term option is to repair the membrane for active leaks and then replace the system as soon as monies allow.

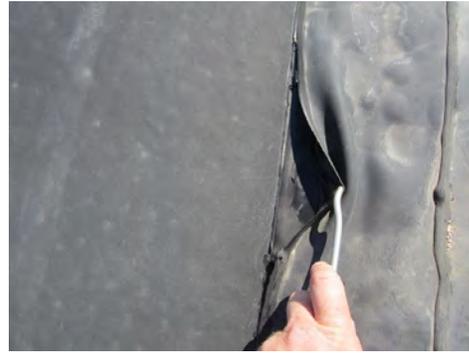
Photo 4

Seam between the two lower roof sections has failed. Water is entering the roof system in this area.

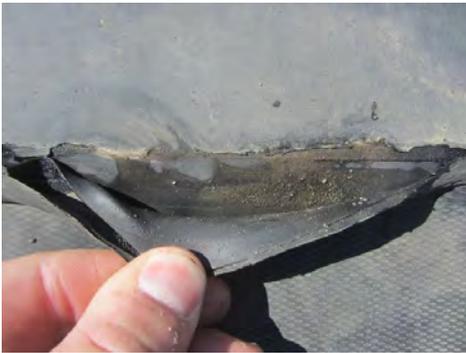
Photo 5

Close up showing moisture in the roof system.
