AGENDA

Board of Public Works Meeting
Tuesday, January 27, 2015 – 7:00 P.M.
Jackson Village Hall
N168W20733 Main Street

Public Works Report

Definitions of Conditions Found on Your Roof

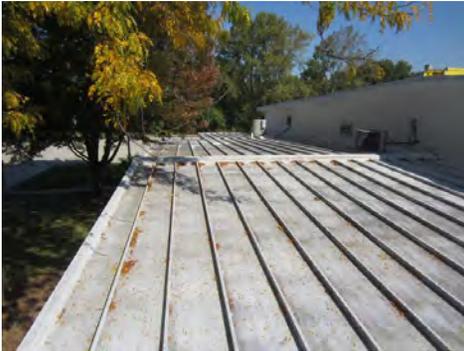
Photo 1

Overview and West perimeter

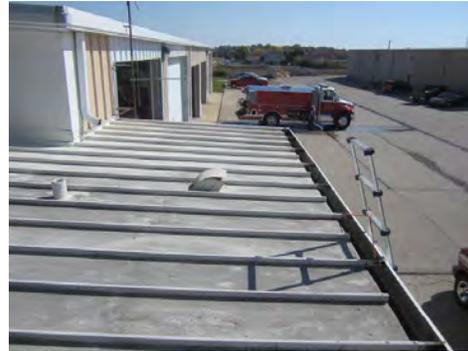
Photo 2

South perimeter

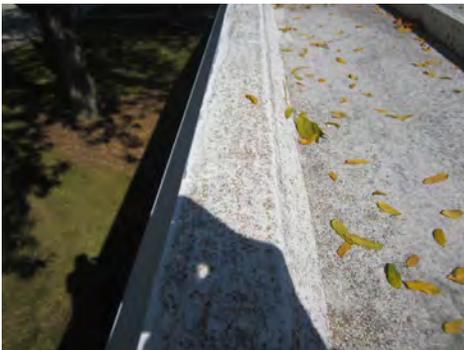
Photo 3

Condition Due to design limitations and age, this roof is at the point where consistent maintenance may be needed. The coating that was installed recently to extend the roof's life has failed and is no longer protecting the original roof. The village should only pursue active leaks until additional monies are available to replace or restore this section.

Close up of the pitting of the coating.

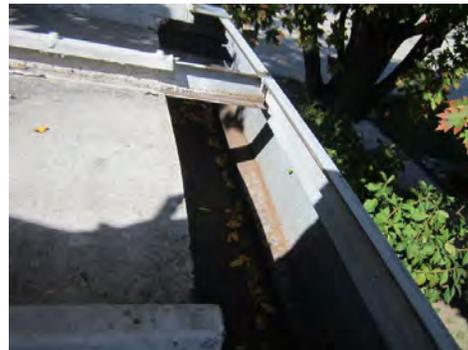
Photo 4

Gutter along the North perimeter

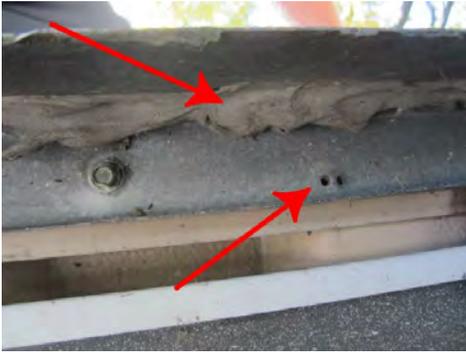
Photo 5

Close up of metal edge detail along the North perimeter. Arrows are pointing to areas where water can enter the system and building.

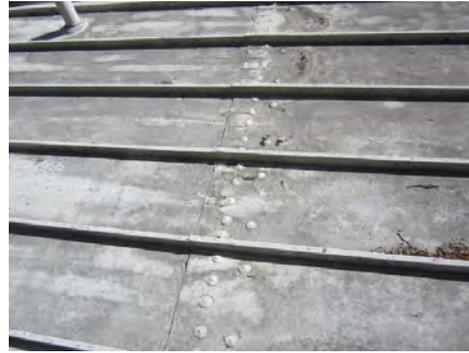
Photo 6

Lap seam where panels meet.

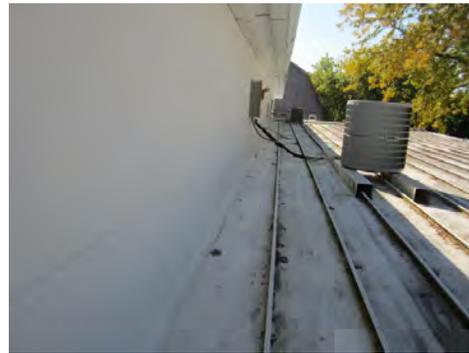
Photo 10

East perimeter

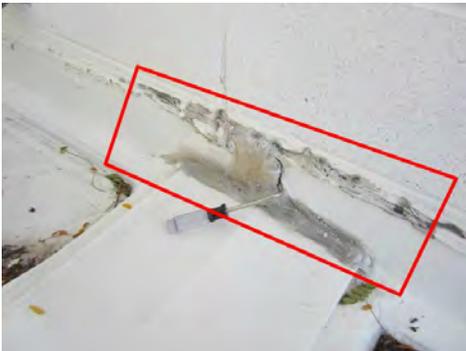
Photo 13

Excessive amounts of caulk applied throughout the years, some of which is no longer watertight.

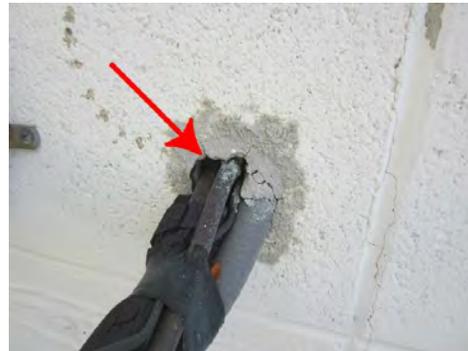
Photo 14

Wall penetration where sealant is no longer watertight.

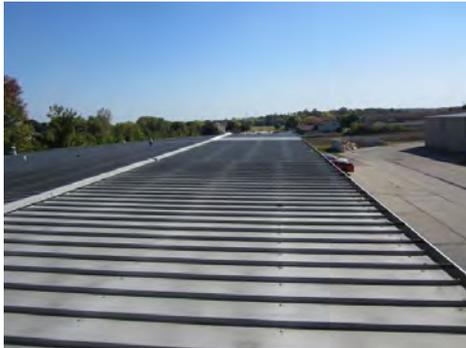
Photo 1

Overview and South perimeter

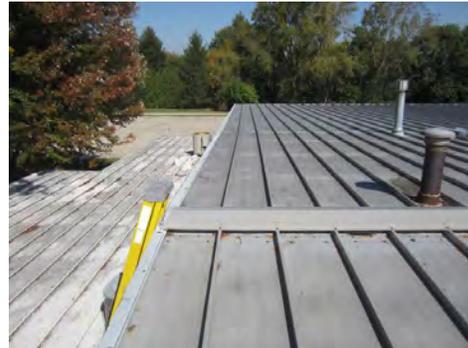
Photo 2

West perimeter

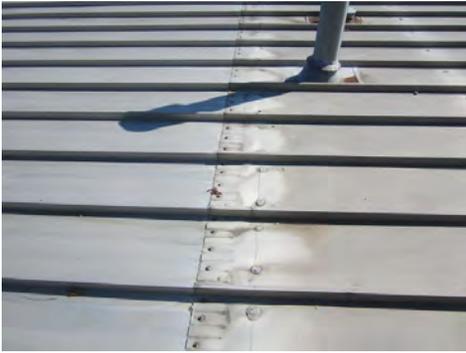
Photo 3

Lap seam where panels meet each other.

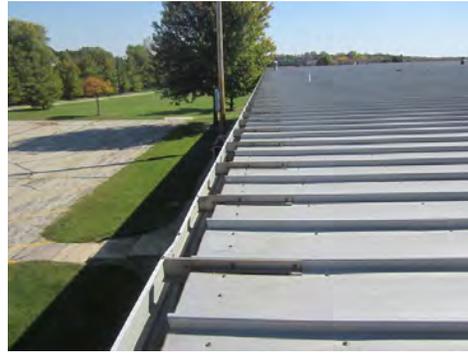
Photo 4

Gutter detail along the North perimeter.

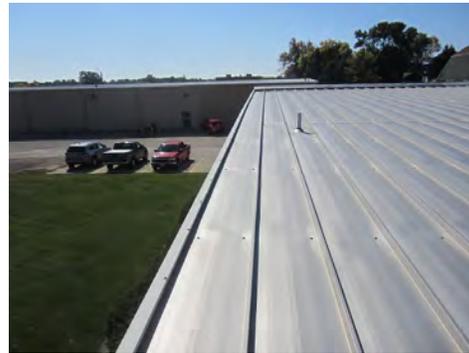
Photo 10

East perimeter

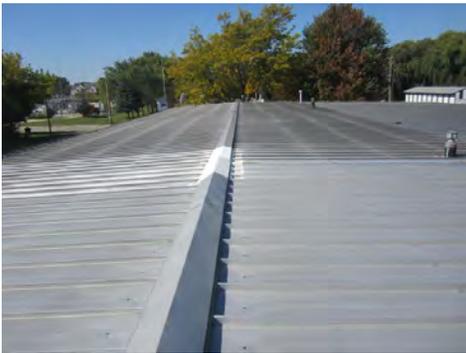
Photo 11

Ridge

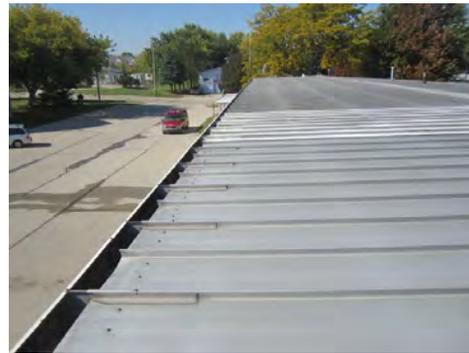
Photo 12

South perimeter

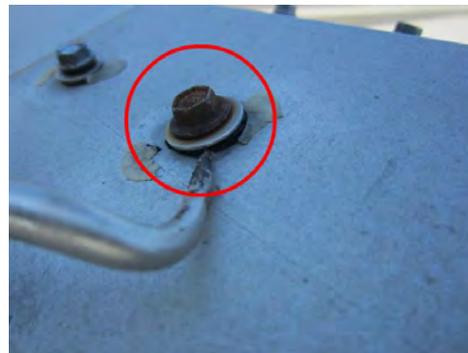
Photo 16

Fastener that is no longer watertight and should be resealed.

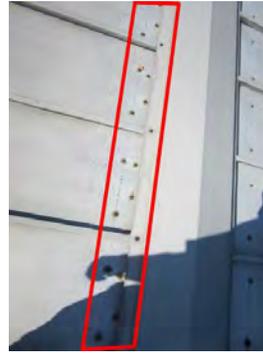
Photo 20

The details on the ridge cap are consistent.

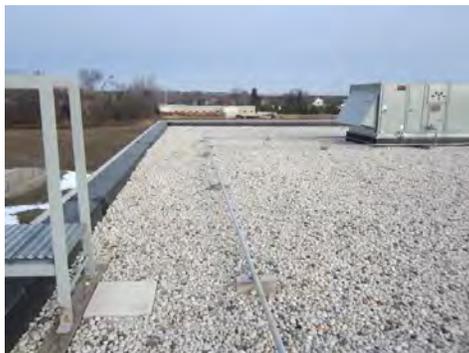
Photo 1

West perimeter

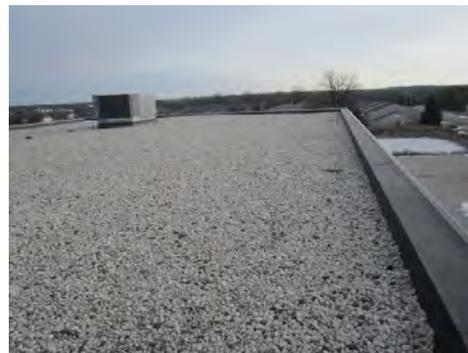
Photo 2

Overview and South perimeter

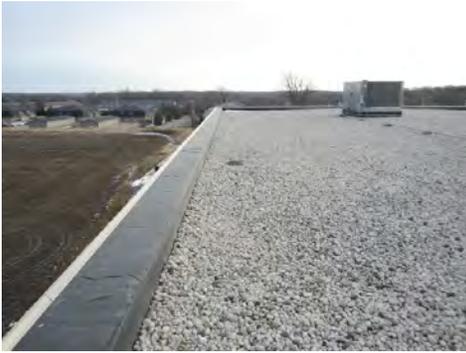
Photo 3
North perimeter

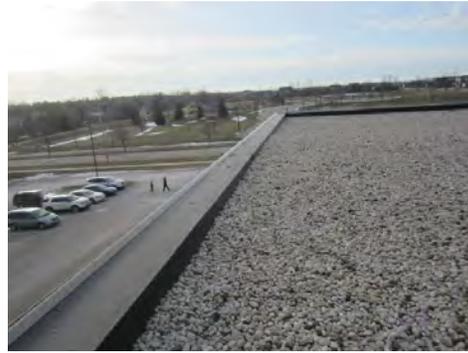
Photo 4
East perimeter

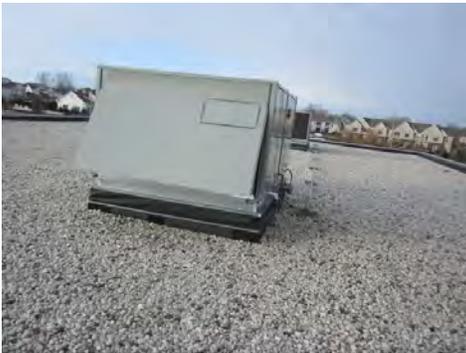
Photo 5
HVAC unit

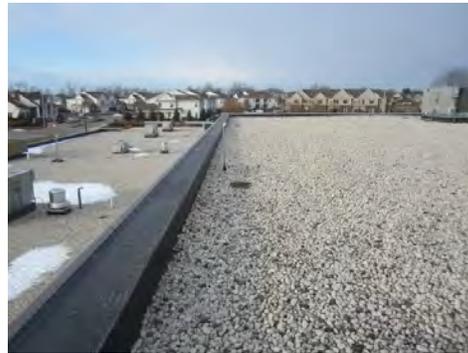
Photo 6
South perimeter

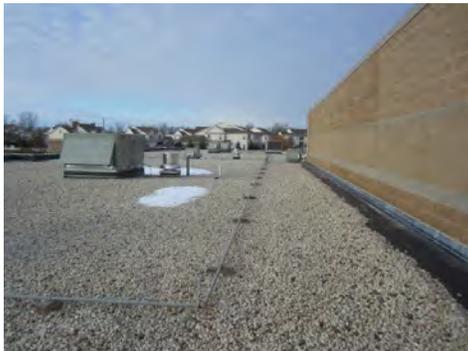
Photo 1

Overview and North perimeter along gym wall.

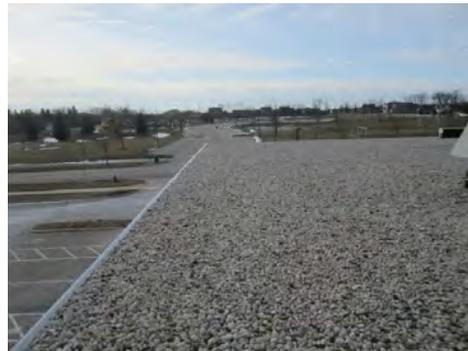
Photo 2

East perimeter

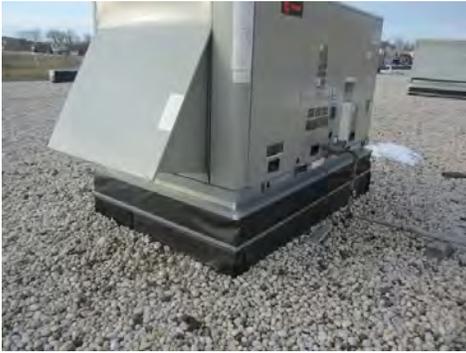
Photo 3

Close up of flashing detail around HVAC unit.

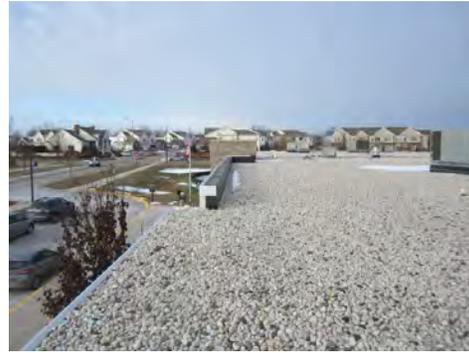
Photo 4

South perimeter

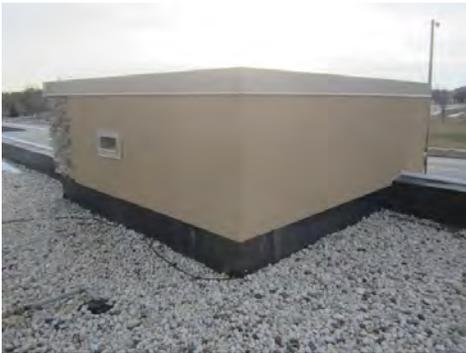
Photo 5

Flashing and wall detail around section 3.

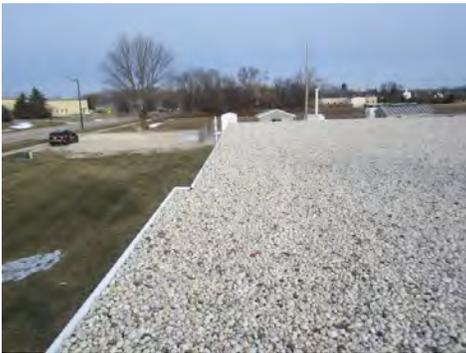
Photo 6

South perimeter

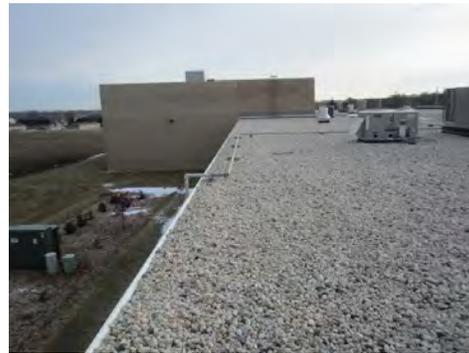
Photo 7

West perimeter

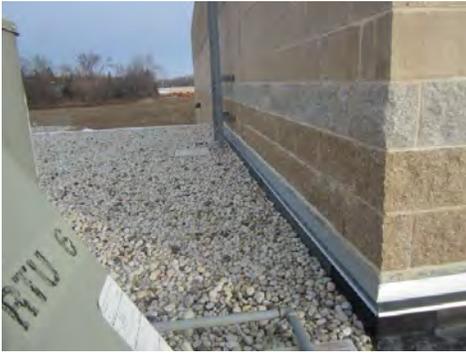
Photo 8

North perimeter

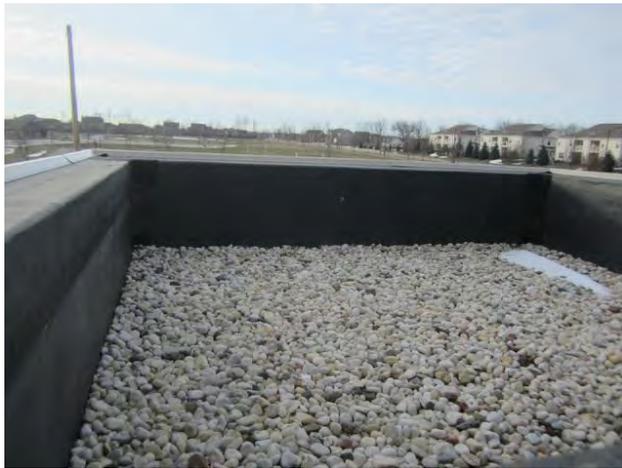
Photo 1

East and South perimeters

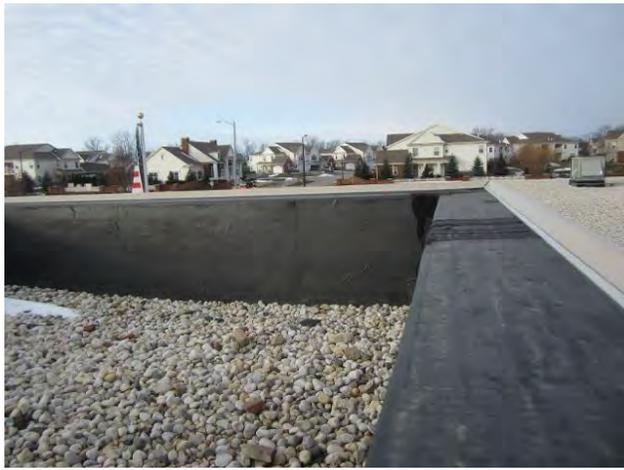
Photo 2

North and West perimeters

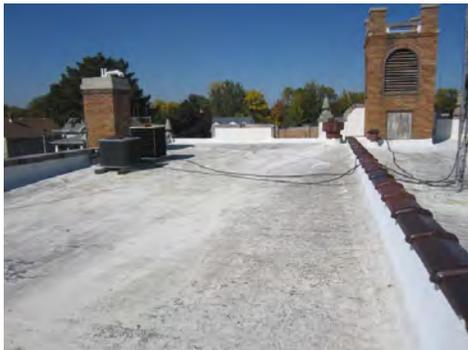
Photo 1

Rating	Poor
Condition	<p>This roof system's age is unknown but is beyond the intended service life. A combination of age related deficiencies and inherent design limitations puts the operations underneath this roof at great risk.</p> <p>As the roof requires more maintenance and the corresponding roof traffic increases, the potential for the thinning single ply membrane to get punctured from things like sharp stone edges, tools, etc. will also increase.</p> <p>There is no insulation above the roof deck causing poor thermal efficiency costing hundreds if not thousands in wasted energy costs.</p> <p>The best long term option is to repair the membrane for active leaks and then replace the system as soon as monies allow.</p>

Overview of roof section

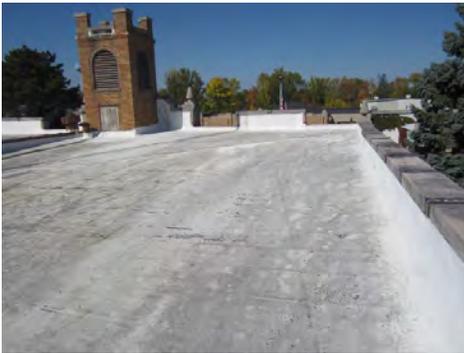
Photo 1

Overview and East perimeter

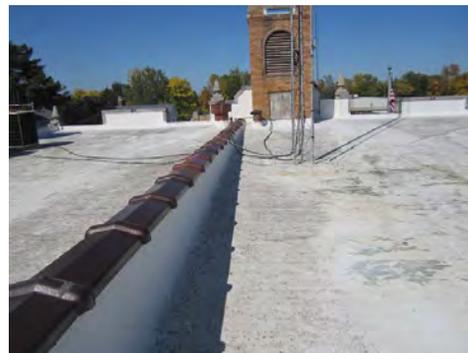
Photo 4

West perimeter

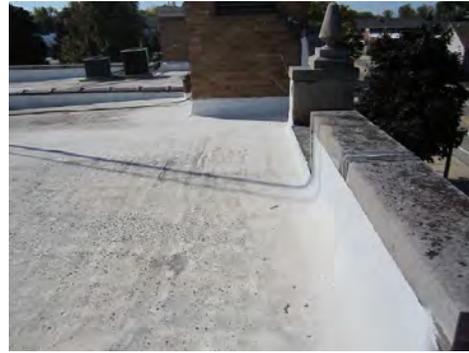
Photo 6

North perimeter

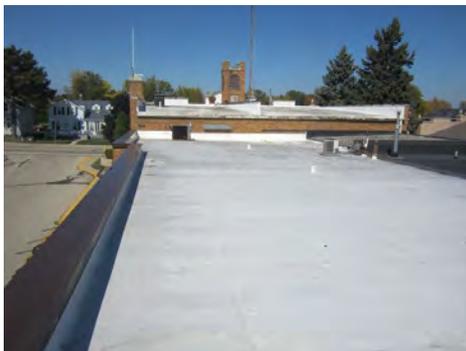
Photo 1

Overview and West perimeter

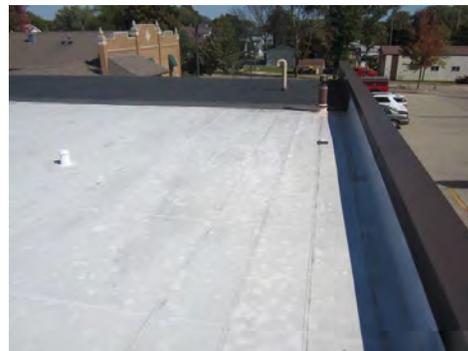
Photo 2

South perimeter

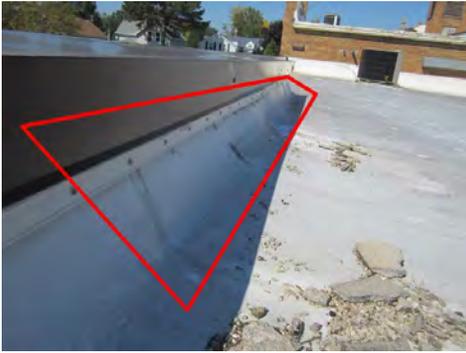
Photo 3

Rating	Failed
Condition	The entire perimeter along the East side of this section is failing and allowing water to enter the system. Single Ply Tenting is occurring along the West perimeter. The termination bar along the North perimeter has Caulking Deterioration .

Single Ply Tenting along the West perimeter

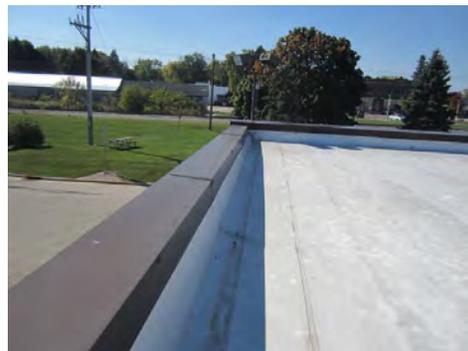
Photo 8

South perimeter

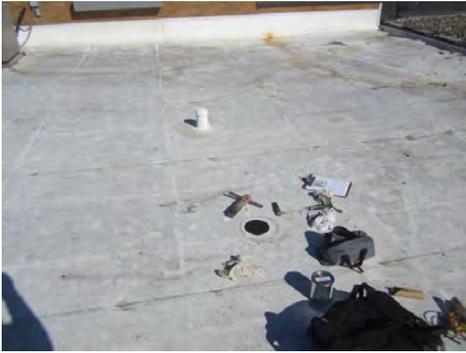
Photo 13

Location of previous photos.

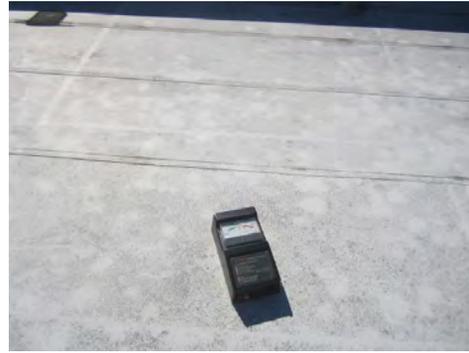
Photo 14

Meter along the South side of the roof is showing the presence of wet insulation.

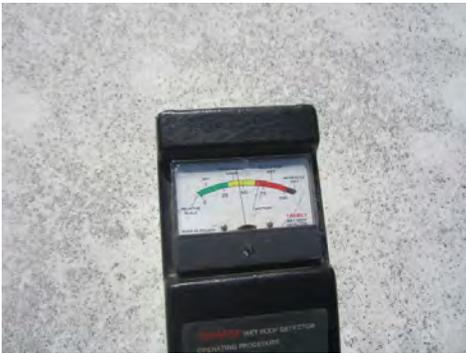
Photo 15

Close up of meter in previous photo.

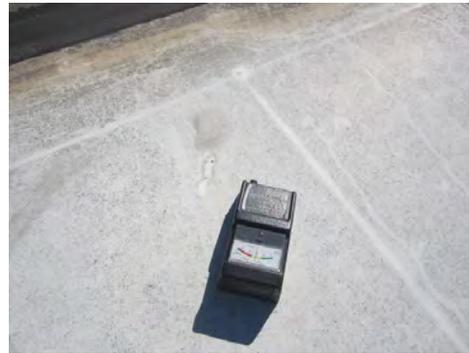
Photo 16

Meter along the East perimeter of the roof is showing the presence of wet insulation.

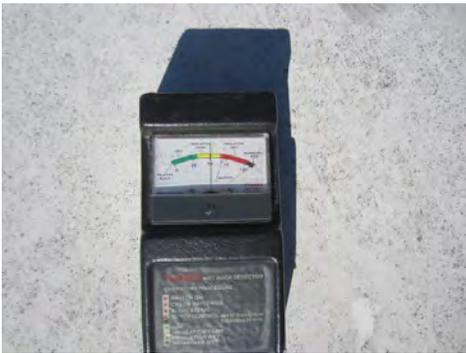
Photo 17

Close up of meter in previous photo.

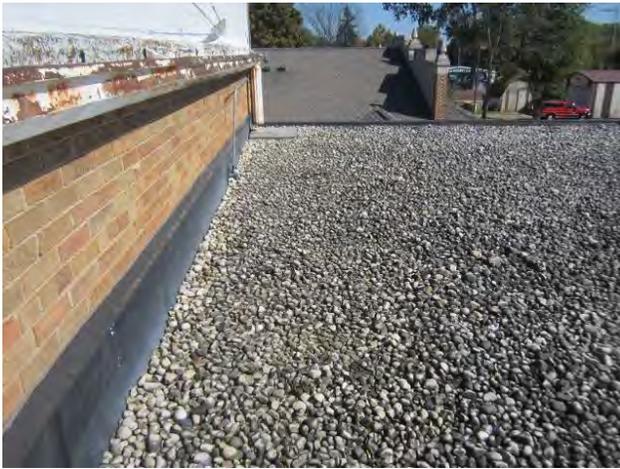
Photo 1

North perimeter

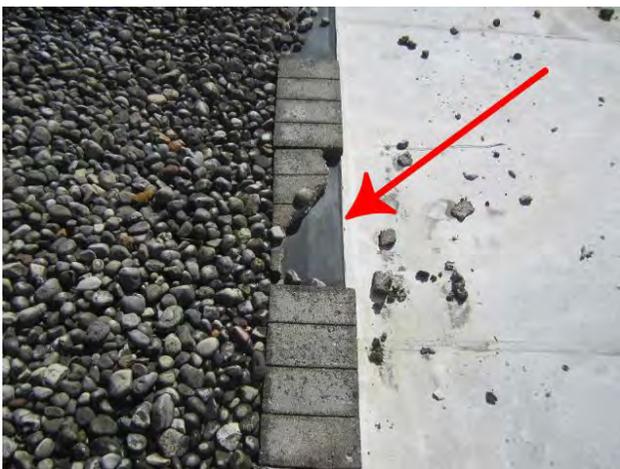
Photo 3

Close up of transition to lower roof section.

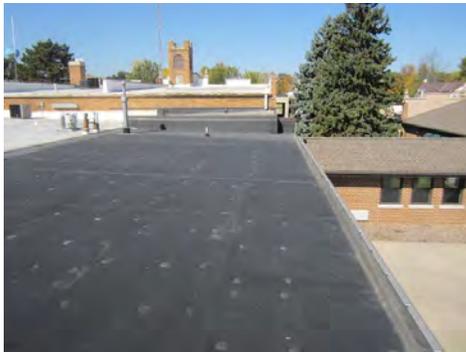
Photo 1

Overview of the roof section.

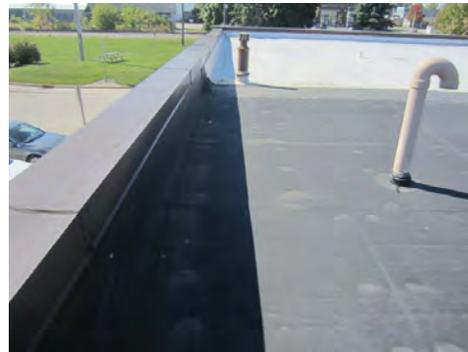
Photo 2

South perimeter

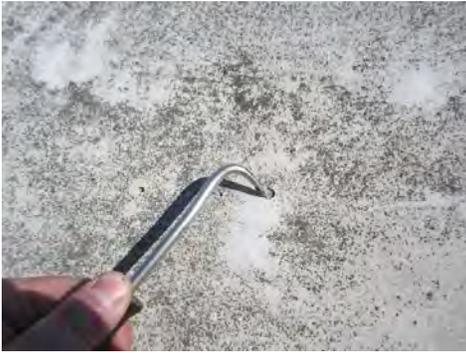
Photo 5

Pitting of the coating

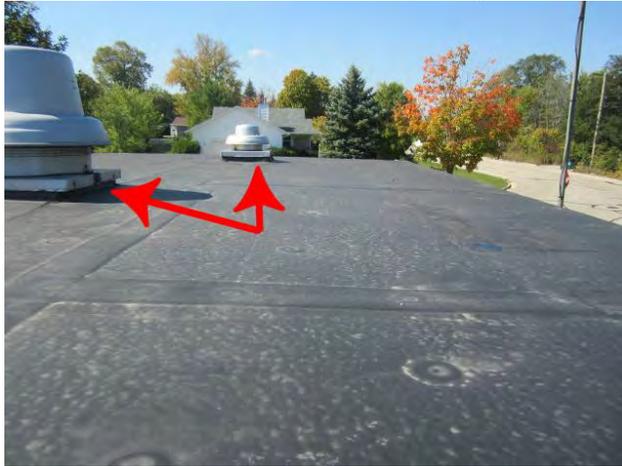
Photo 1

Curbs are low but they are higher than the edge of the roof.
